GEO-TECHNOLOGY ASSOCIATES, INC.

Re: Stormwater Management Testing
Marlton Crossing
Township of Marlton, Burlington County, New Jersey

Test Pit Exploration

Infiltration Testing

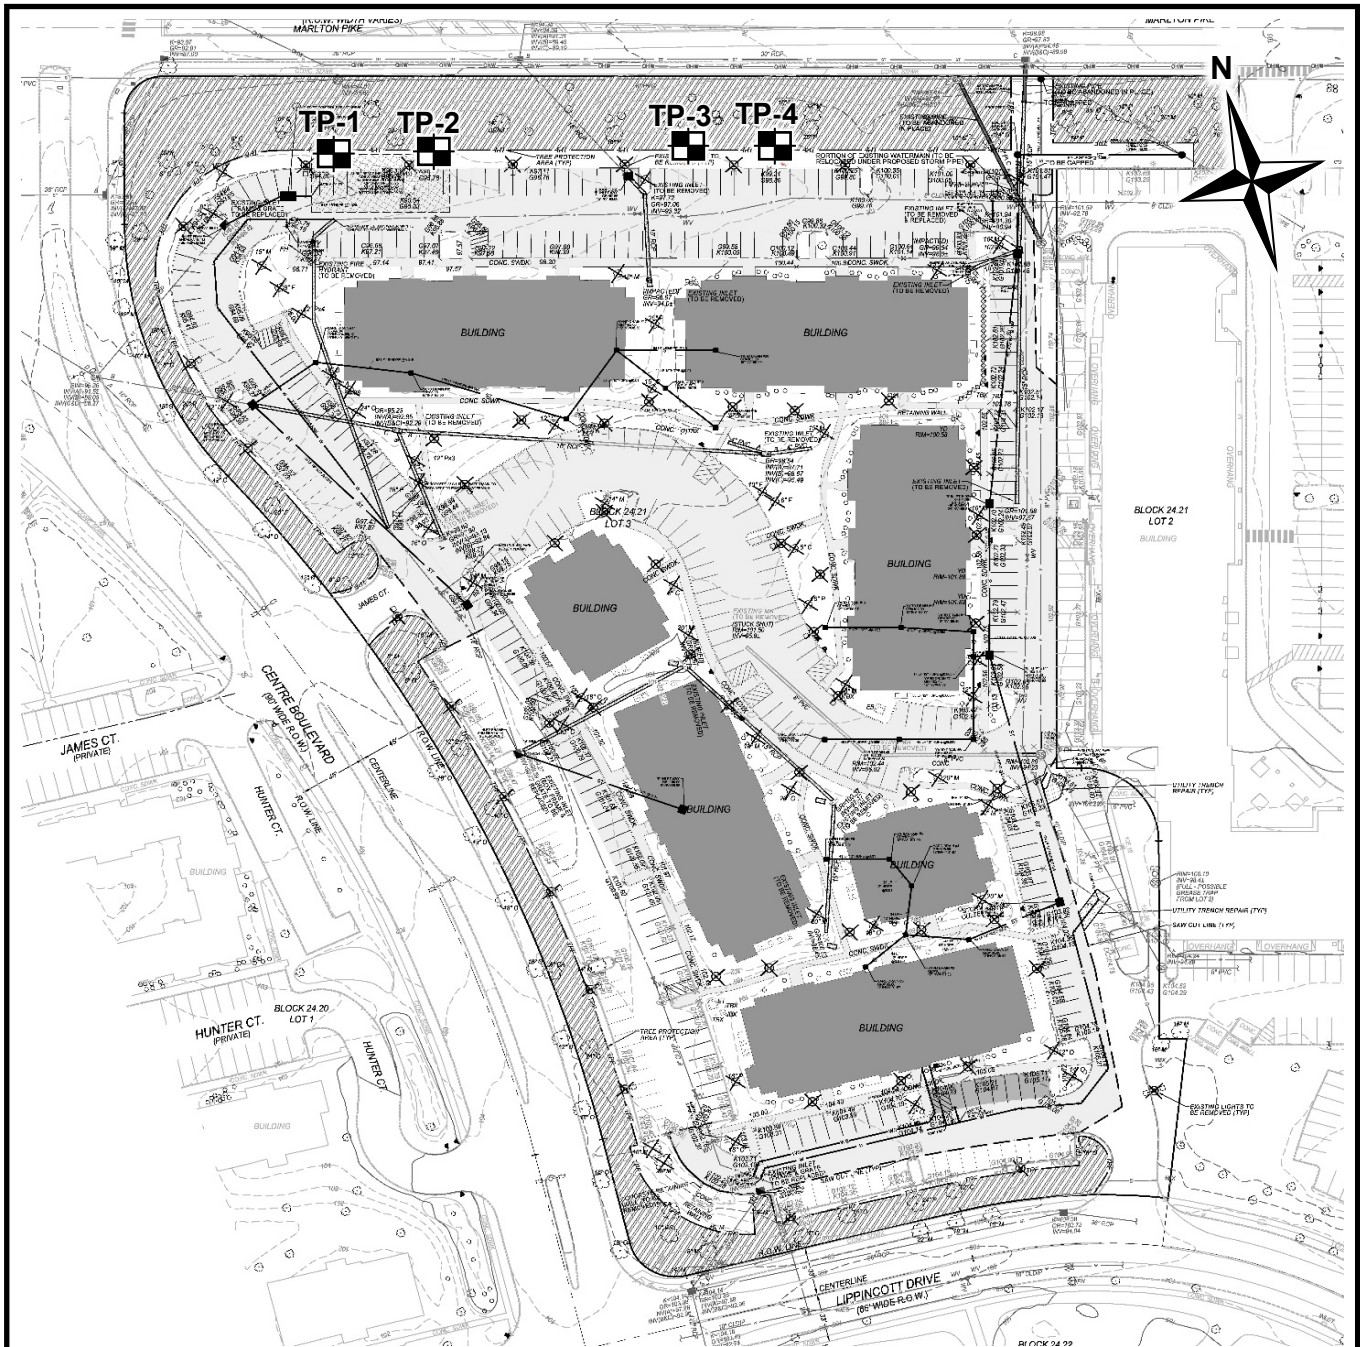
*Base plan prepared by Taylor Wiseman & Taylor titled "Demolition Plan" dated June 26, 2025.

A plan prepared by Taylor Wiseman & Taylor (TW&T) titled "Demolition Plan" dated June 26, 2025 was provided to GTA. The plan indicates the site boundaries, existing site features and topography, and was marked up to show the requested locations of 4 explorations within the proposed and potential SWM basin areas. The plan indicates that a proposed subsurface infiltration basin with a footprint area of approximately 3,500 square feet and a basin bottom elevation established at Elevation 90.0 feet will be sited in the northeastern corner of the site. Another potential SWM basin area is also indicated on the plan, adjacently east of the proposed basin in the northern portion of the site.

On August 21, 2025, GTA observed and logged the excavation of 4 test pits and performed in-situ infiltration testing at the requested locations. The test pits were excavated by J.A. Neary Excavating using a Case CX160 excavator and extended to depths ranging from approximately 14 to 18 feet below the existing ground surface. Preliminary in-situ infiltration testing was performed adjacent to each of the test pits using a double-ring infiltrometer. The exploration locations were selected by TW&T and
